Your Inspection Report

167 Welland Avenue
Toronto, ON M4T 2J6

INSPECTION DATE:
Monday, April 13, 2026

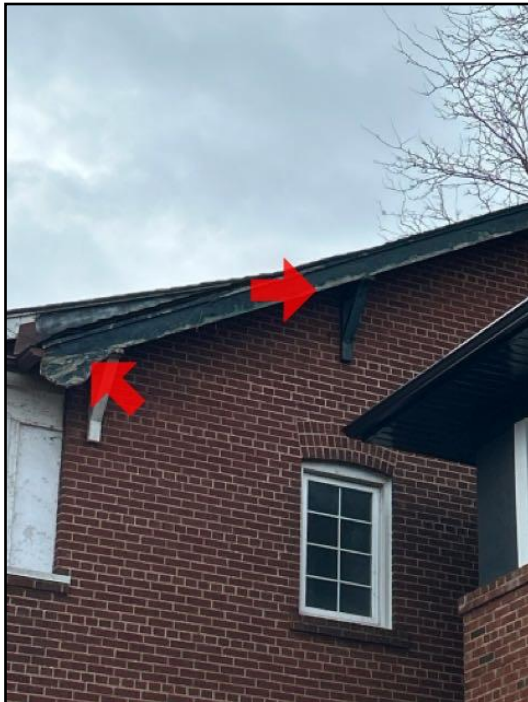
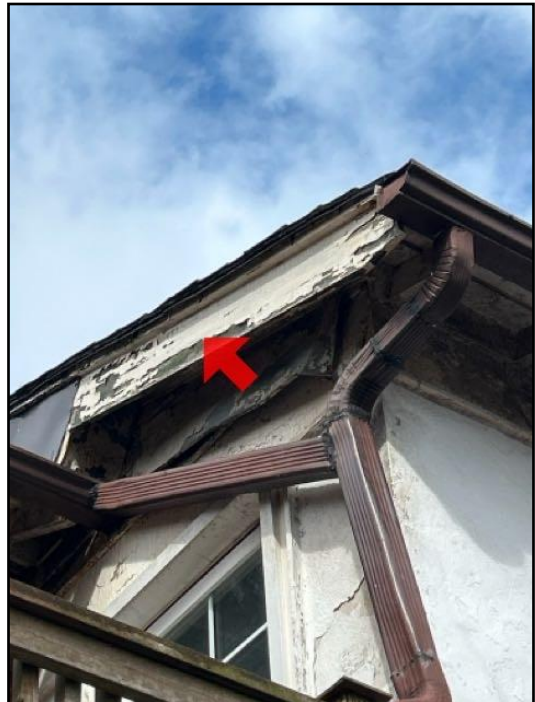
WALLS \ Soffits (underside of eaves) and fascia (front edge of eaves)

Condition: • Paint - deteriorated / missing

Paint - deteriorated / missing

Task: Repair

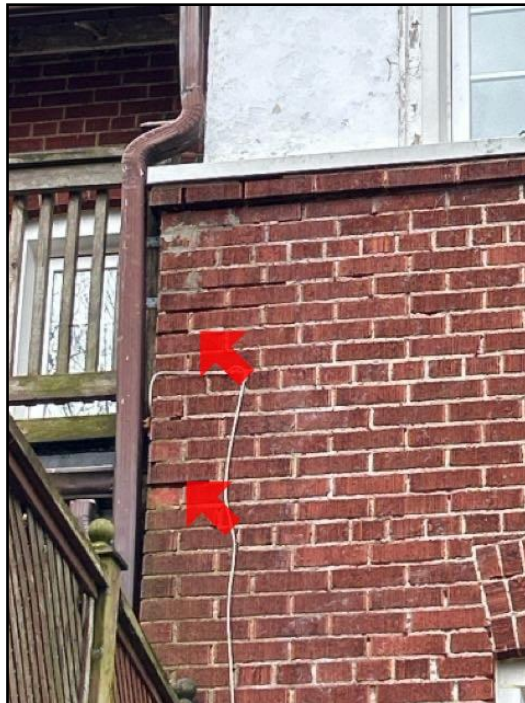
Condition: • [Mortar deterioration](#)

Implication(s): Chance of water entering building | Weakened structure | Chance of structural movement

Mortar deterioration

Task: Repair

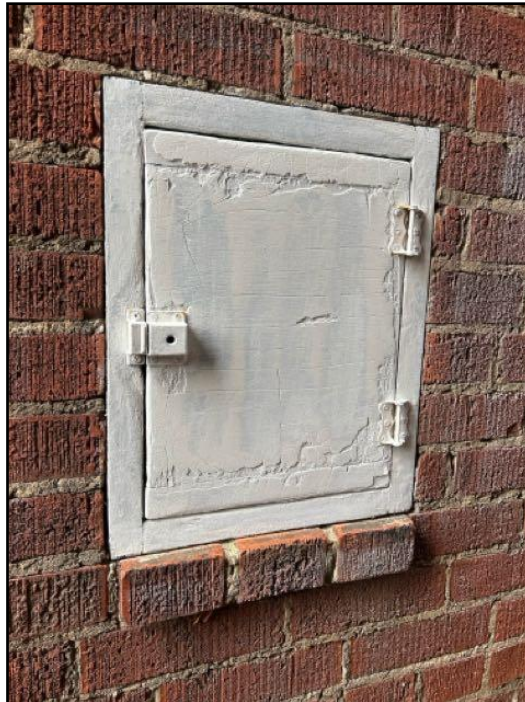
Condition: • Abandoned milk box

Implication(s): Increased heating and cooling cost, reduced comfort, risk of water infiltration/damage

Abandoned milk box

Old milk boxes are a point of heat loss. To properly abandon it, remove the door and frame, insulate the cavity and patch the wall.

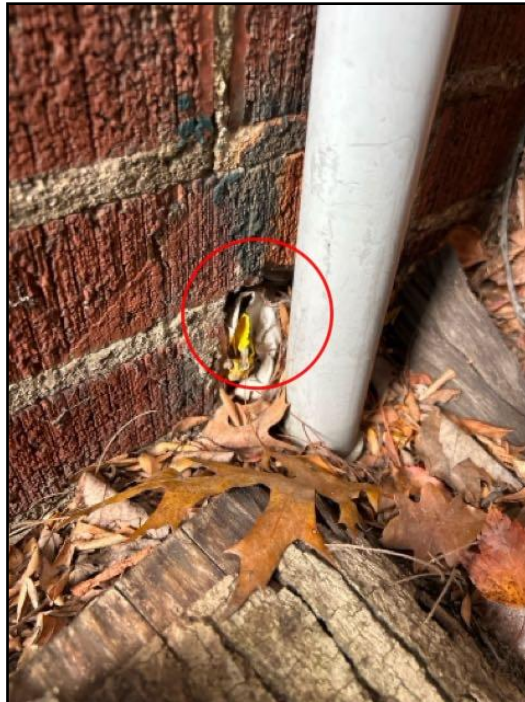
Condition: • Improperly patched hole

Implication(s): Risk of water infiltration, pests

Improperly patched hole

Task: Repair

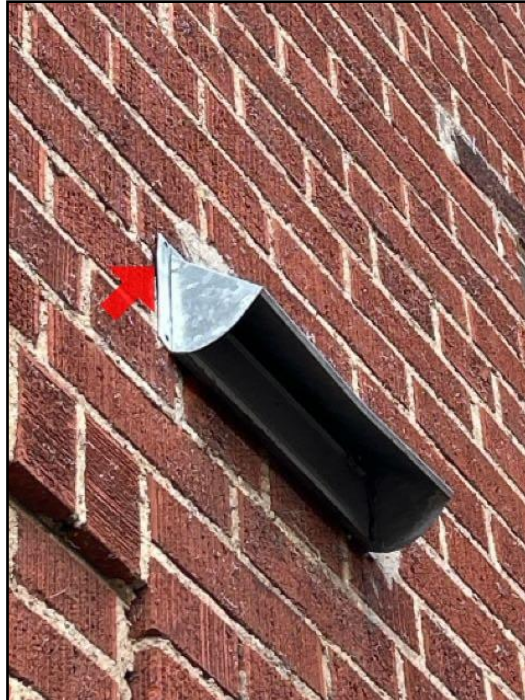
WALLS \ Vent (fan, clothes dryer, etc.)

Condition: • Caulking deteriorated/missing

Caulking deteriorated/missing

Task: Provide

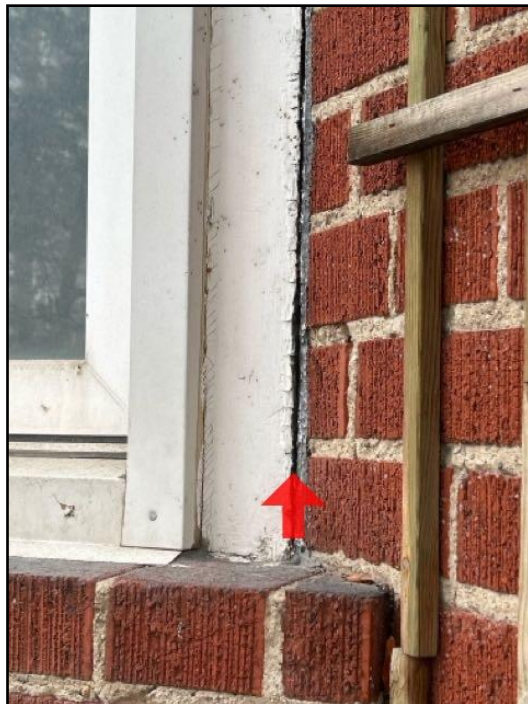
Condition: • [Caulking missing, loose or deteriorated](#)

Implication(s): Chance of water damage to structure, finishes and contents

Caulking missing, loose or deteriorated

Task: Repair

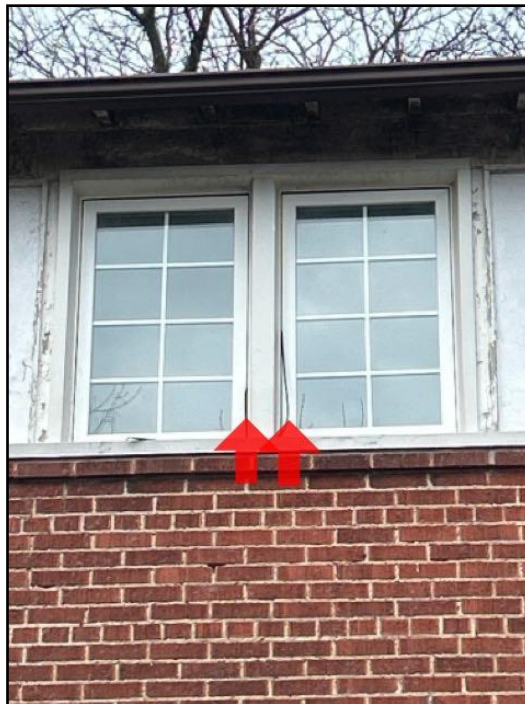
Condition: • [Poor weatherstrip](#)

Implication(s): Chance of water entering building | Increased heating and cooling costs | Reduced comfort

Poor weatherstrip

Task: Repair

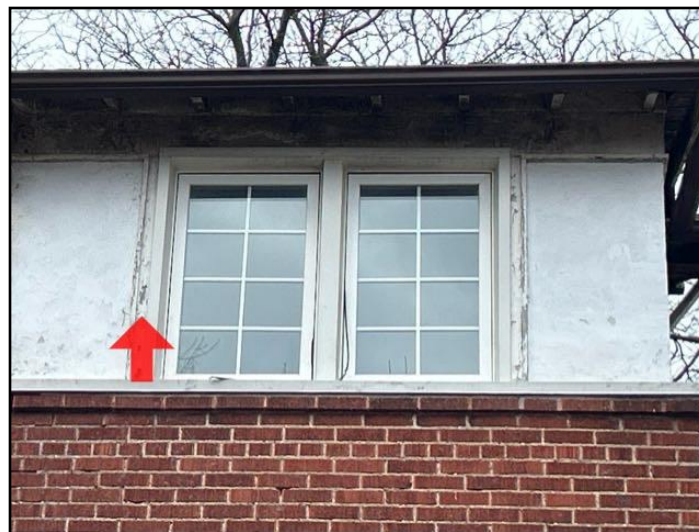
Condition: • [Paint or stain needed](#)

Implication(s): Chance of water damage to structure, finishes and contents | Material deterioration

Paint or stain needed

Task: Repair

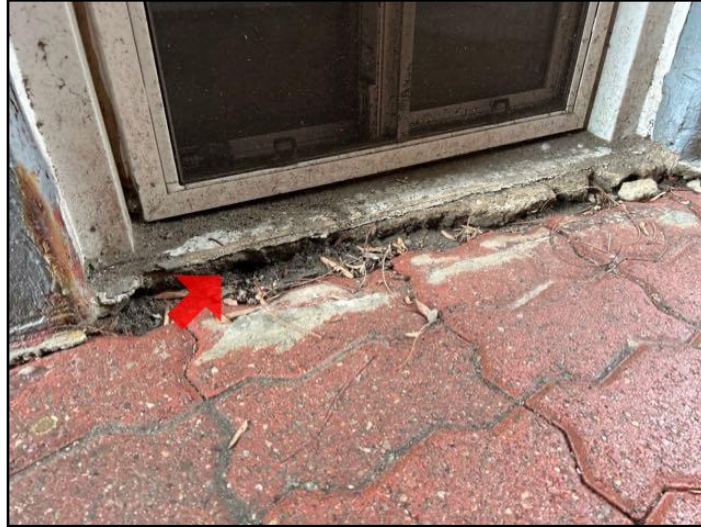
Condition: • [Sill deteriorated](#)

Implication(s): Material deterioration

Sill deteriorated

Task: Repair

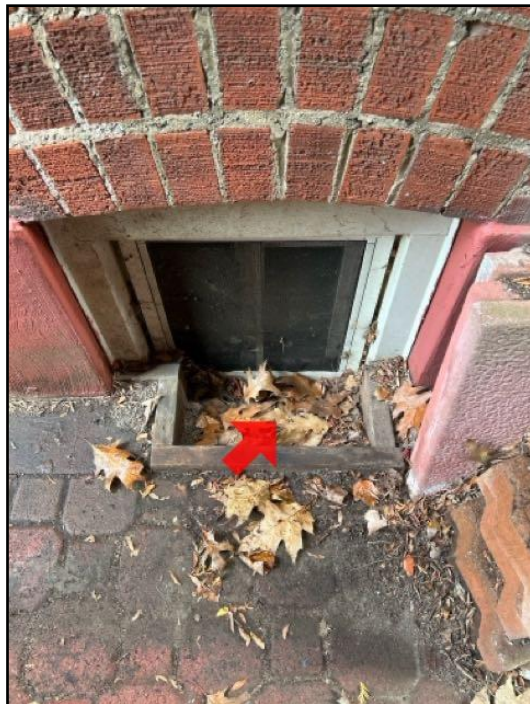
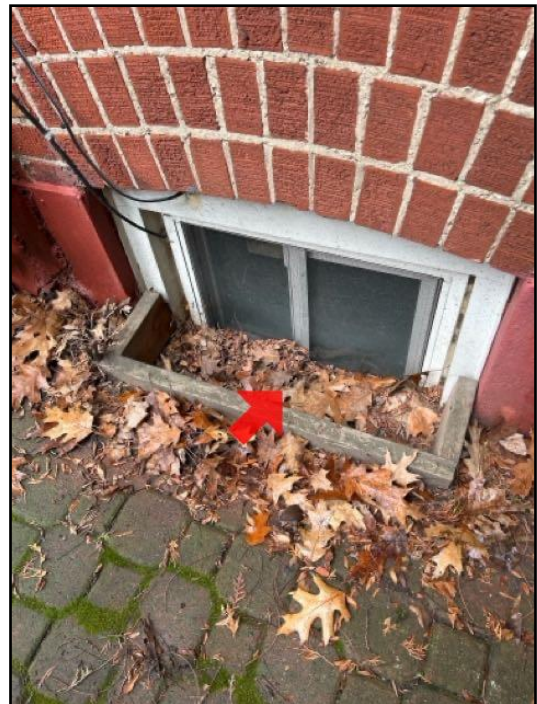
Condition: • [Less than 6 inches below window](#)

Implication(s): Chance of water entering building

Less than 6 inches below window

Task: Improve

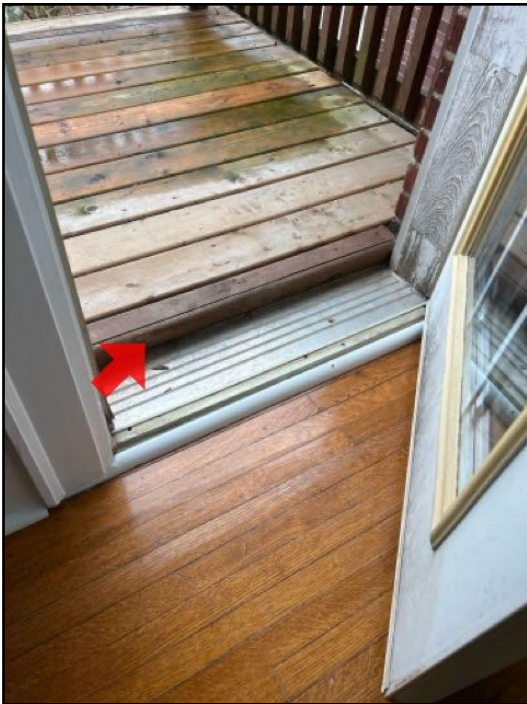
Condition: • [No step up into building](#)

Implication(s): Chance of water damage to structure, finishes and contents | Material deterioration

No step up into building

Keep door area cleared of snow in winter.

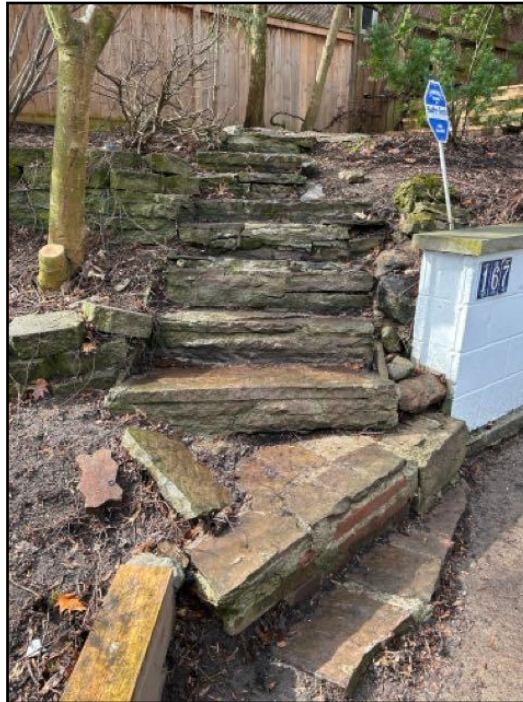
Condition: • [Steps or landings settling or heaving](#)

Implication(s): Weakened structure | Trip or fall hazard

Steps or landings settling or heaving

Task: Repair

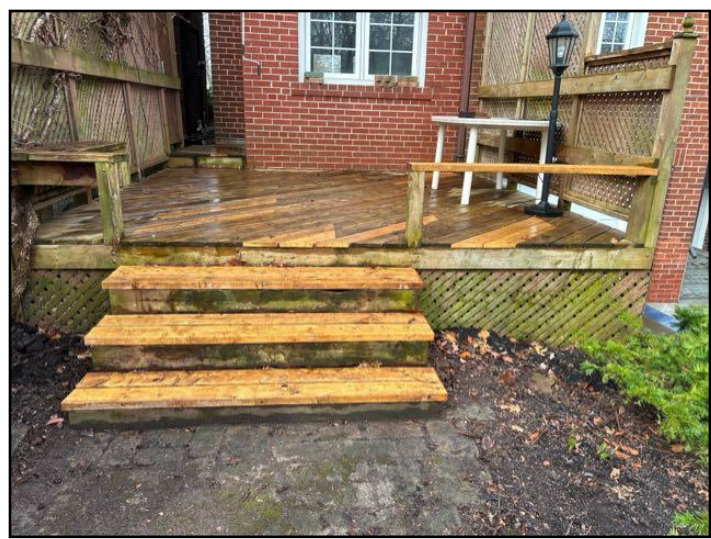
Condition: • Guard and handrail issues: Handrail missing at steps, guard rail too low and lacks spindles

Implication(s): Fall hazard

Guard and handrail issues

Task: Improve

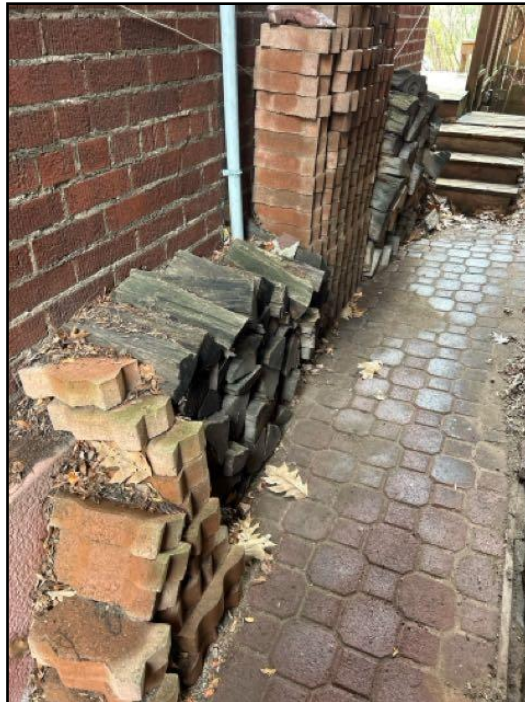
Condition: • Firewood stored against exterior wall

Implication(s): Risk of pests, insects

Firewood stored against exterior wall

Task: Remove or relocate

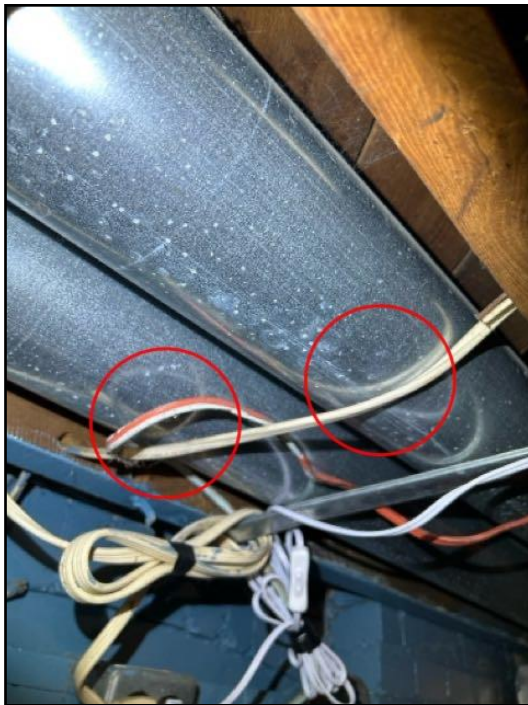
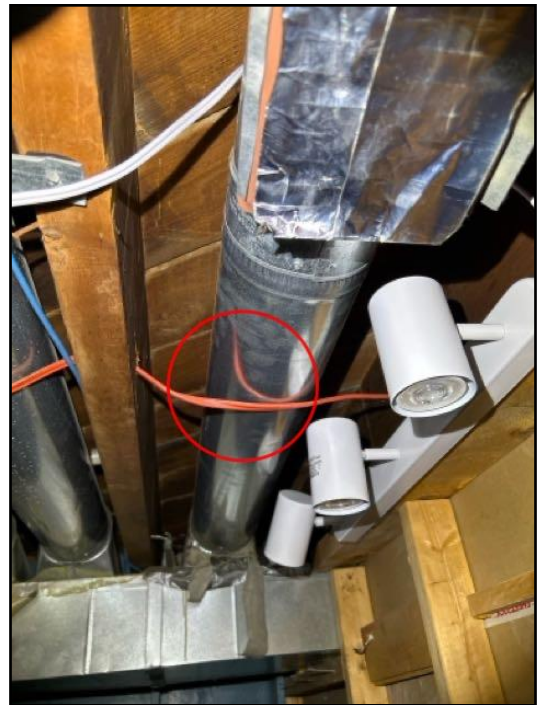
Condition: • [Too close to/touching duct, pipe, vent or chimney](#)

Implication(s): Electric shock | Fire hazard

Too close to/touching duct, pipe, vent or...

Task: Improve

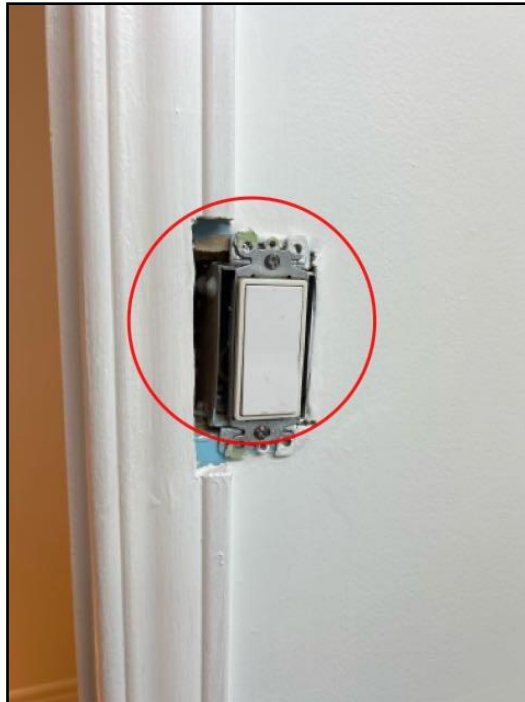
Condition: • [Missing](#)

Implication(s): Electric shock

Missing cover plate

Task: Provide

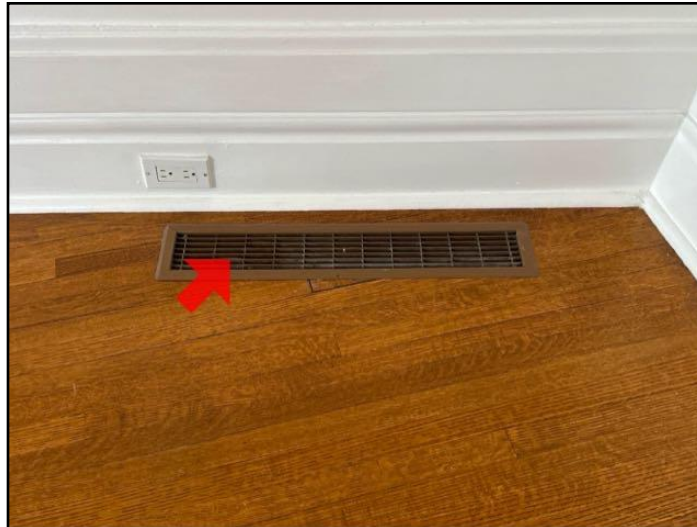
Condition: • Return too small

Implication(s): Increased heating and cooling costs, reduced comfort

Return too small

Task: Improve

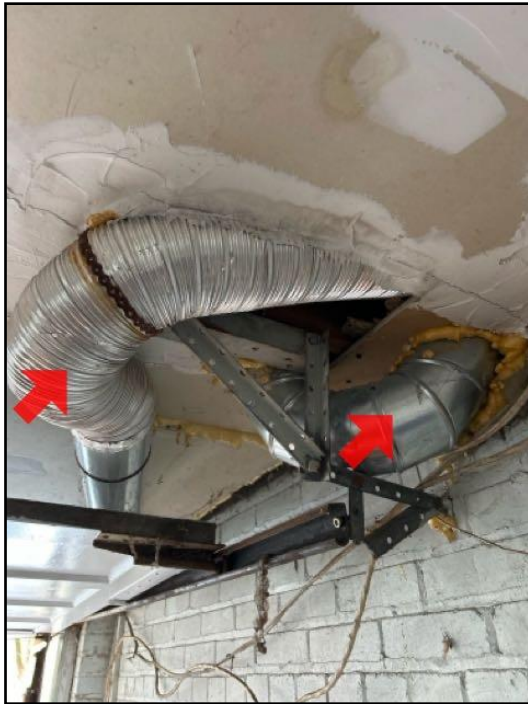
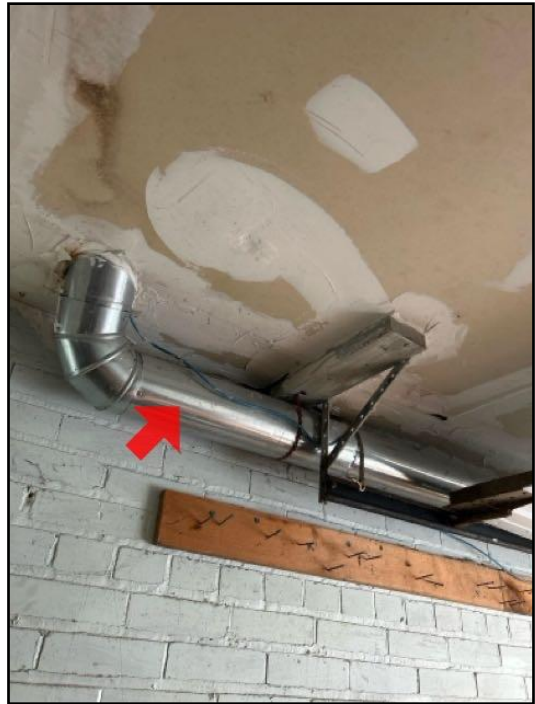
Condition: • [Insulation missing, damaged](#)

Implication(s): Increased heating costs | Reduced comfort

Insulation missing, damaged

Ensure all connections are sealed (to prevent carbon monoxide infiltrating HVAC ducts) and then insulate ducts.

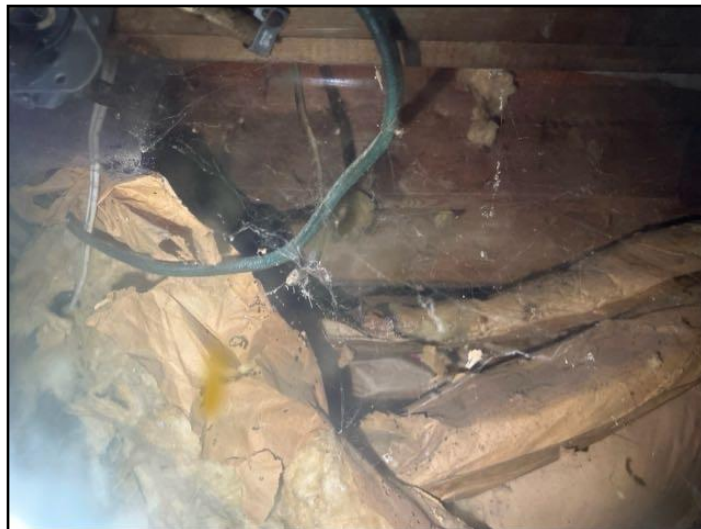
Condition: • Loose, missing - Replace/re-install insulation

Loose, missing insulation

Task: Improve

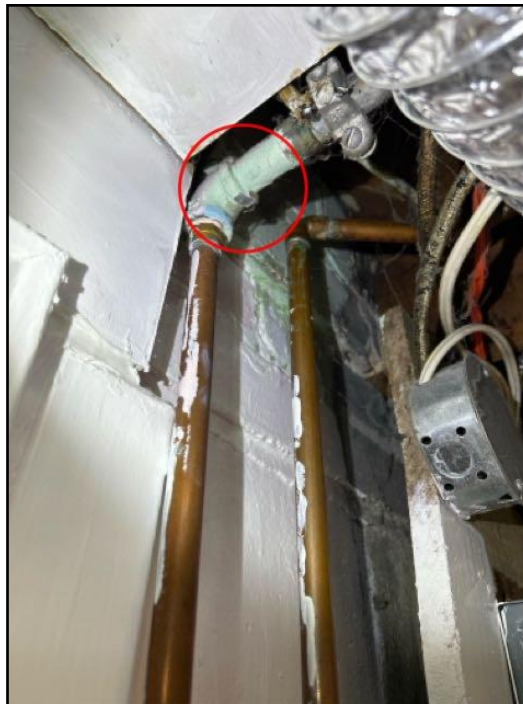
Condition: • [Galvanized steel](#)

Galvanized steel cold water pipe was noted above the water heater - it may run back to the main shut-off valve at the front of the basement. More could be found if doing invasive work (renovations etc).

Implication(s): Reduced water pressure and volume

Galvanized steel

Task: Replace

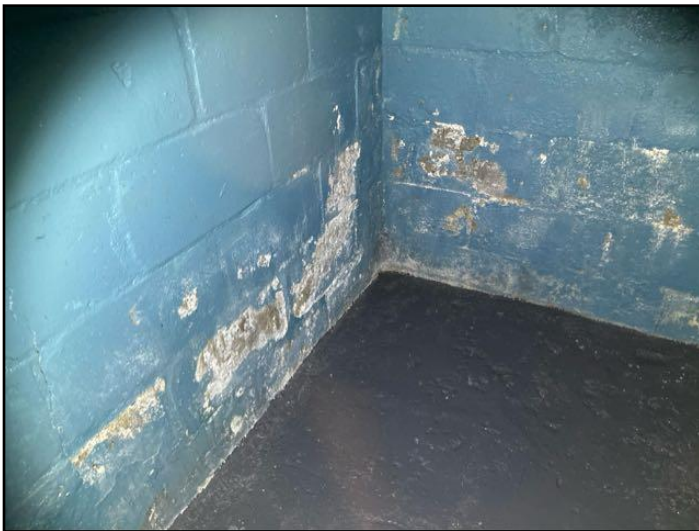
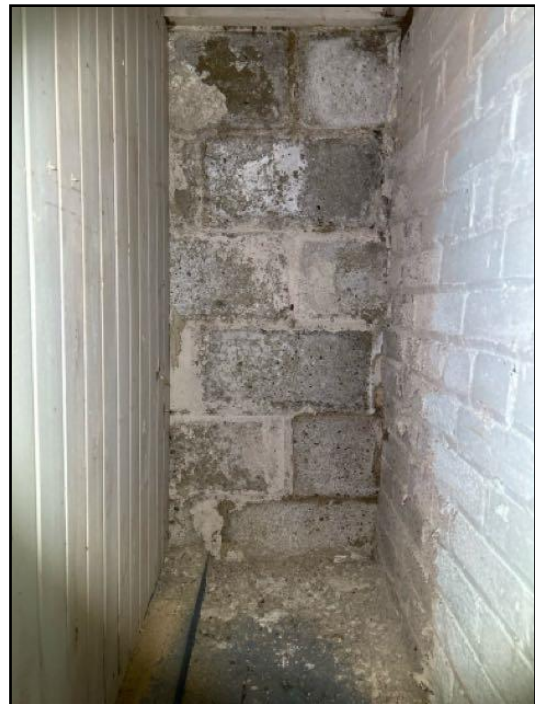
Condition: • [Efflorescence](#)

Efflorescence is common on foundation walls in old houses. No active water issues were noted.

Efflorescence

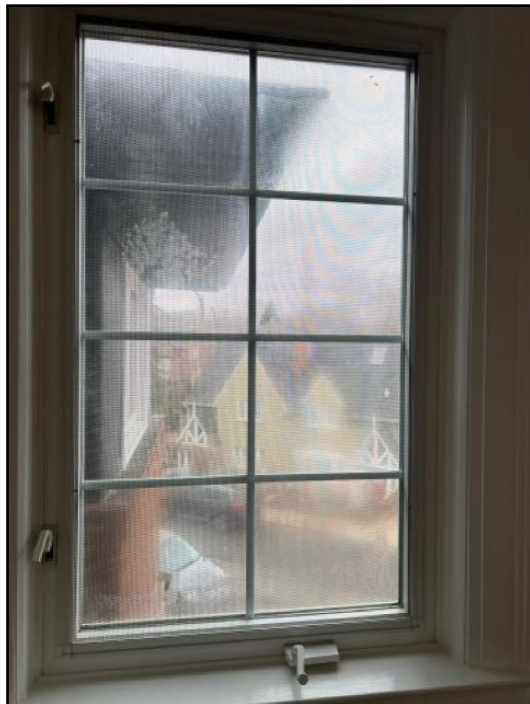
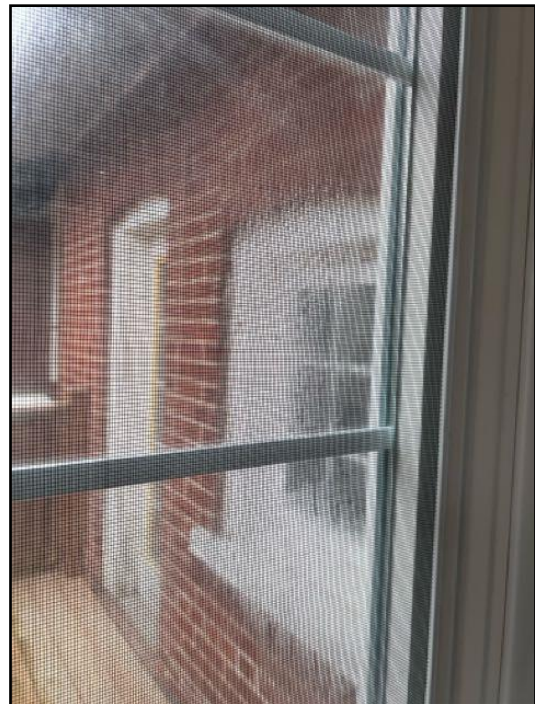
Condition: • Lost seal on double or triple glazing (condensation trapped between the inner and outer glass)

Implication(s): Cosmetic issue, possible reduced energy efficiency

Lost seal on double or triple glazing...

Task: Repair or replace

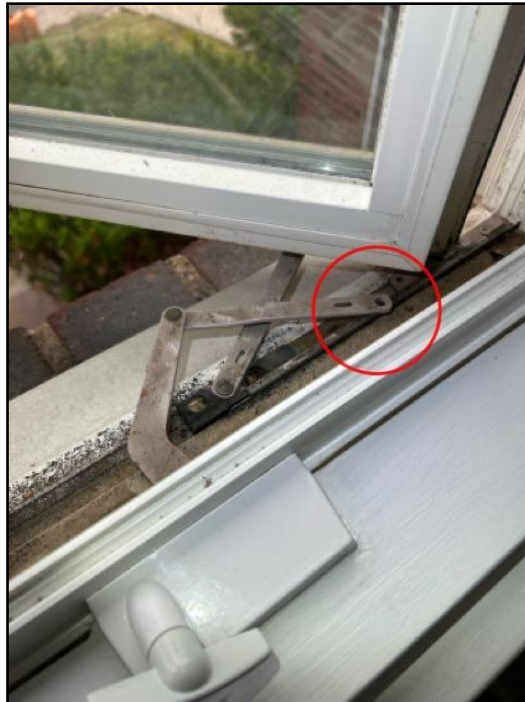
Condition: • [Broken](#)

Loose control arm

Broken - loose control arm

Task: Repair

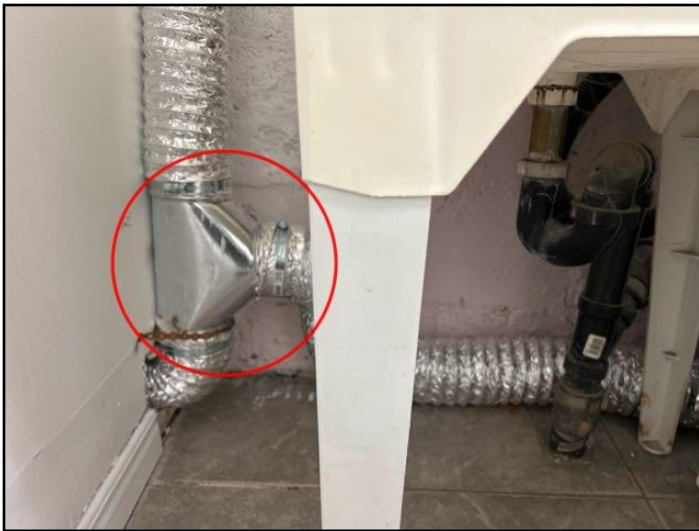
Condition: • Manifolding of dryer and bathroom fan exhaust. Each must have its own dedicated duct venting to the exterior. The duct runs should not be excessively long.

Manifolding of dryer and bathroom exhaust

Task: Improve

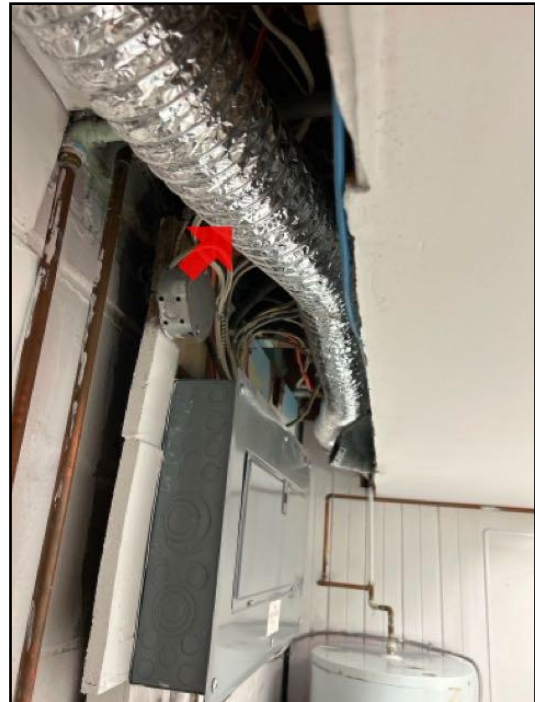
Duct run too long

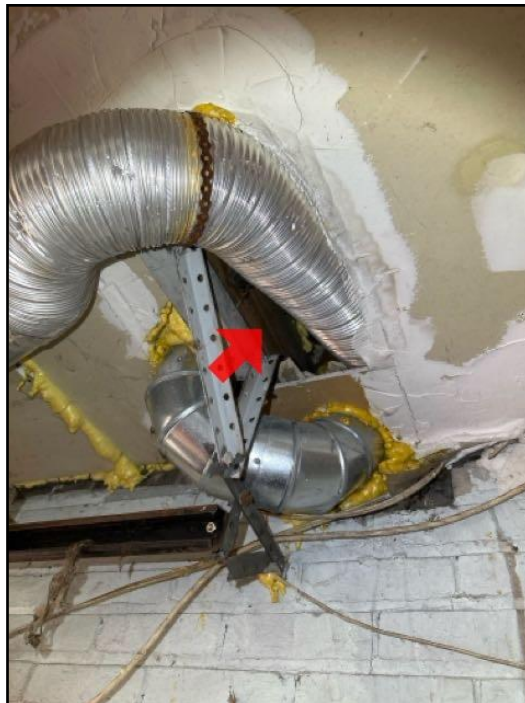
Condition: • [Not gastight](#)

Implication(s): Hazardous combustion products entering home

Not gastight

Task: Repair
